## Modernization and Rehabilitation of Irrigation Infrastructure through Hydraulic and Energy Upgrading of Pumping Stations and Pressurized Pipe Networks – A Technical Case Study in Romania

T.N. Dragomir<sup>1\*</sup>

<sup>1</sup>University of Agronomic Sciences and Veterinary Medicine of Bucharest, Bucharest, Romania.  
Corresponding Author (T.N. Dragomir) Email: [nastydragomir@gmail.com](mailto:nastydragomir@gmail.com)

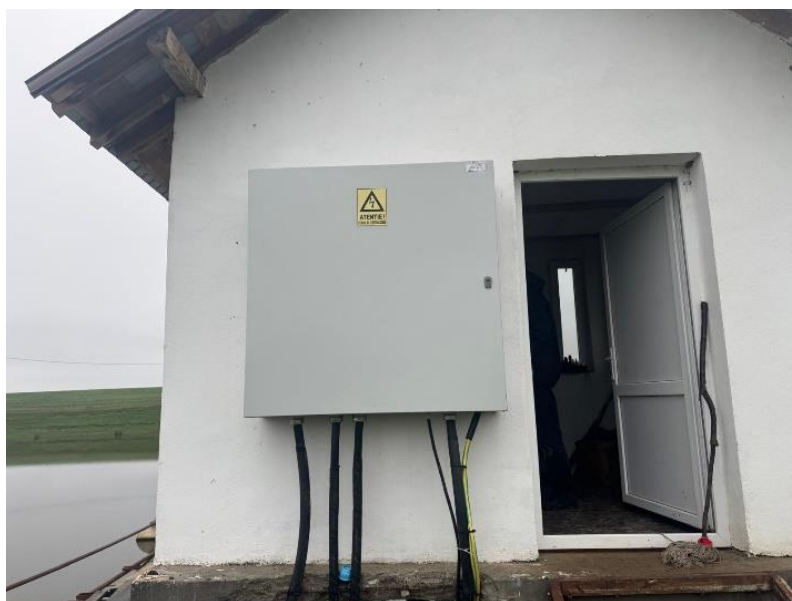
**Figure 1.** General view of the irrigation pumping station supplying the analyzed agricultural area, highlighting the arrangement of pumping units and the main hydraulic components prior to rehabilitation.

To improve energy performance and control accuracy, the pumping station modernization incorporates frequency control devices and automated operation systems. These measures allow for adaptive pump operation, reducing energy consumption under partial load conditions and minimizing hydraulic stress within the network. The general configuration of the pumping station is illustrated in Figures 1 and 2.

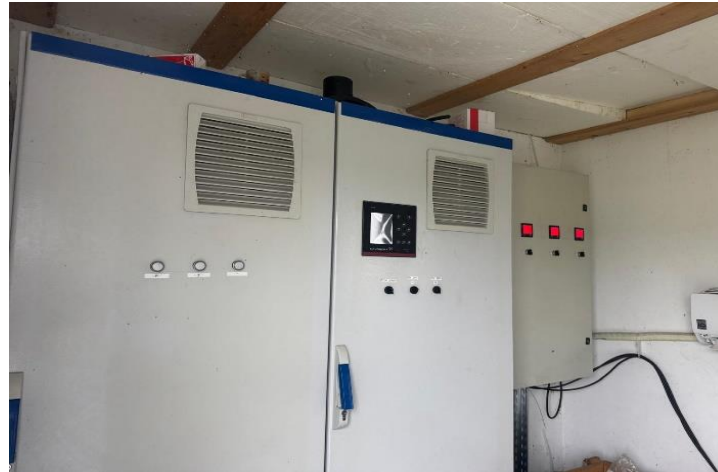
**Figure 2.** Electrical pump starting and control system of the existing pumping station, illustrating the conventional configuration used before the implementation of energy-efficient automation and frequency control.

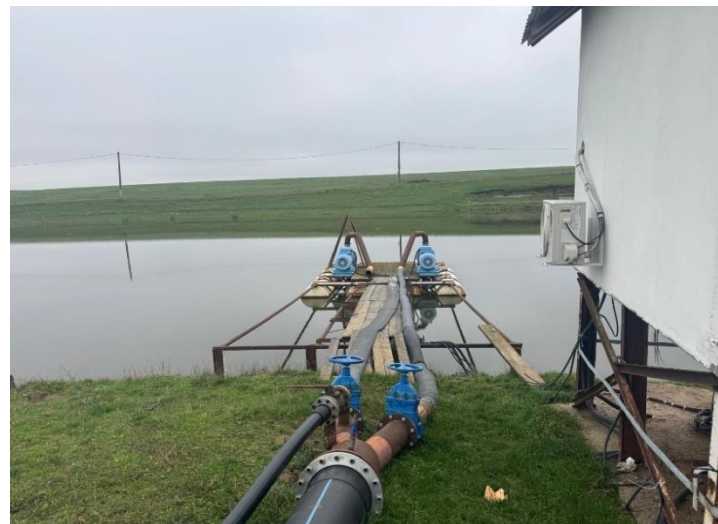
**Figure 3.** Schematic representation of the rehabilitated pressurized pipeline network, showing the main and secondary pipelines, flow direction, and improved hydraulic layout adopted to reduce head losses and ensure pressure stability.

The pipeline network modernization focuses on replacing hydraulically inadequate sections and extending the network to improve water distribution uniformity. Pipe diameters were selected based on calculated flow rates and permissible head losses, ensuring stable pressure conditions at the terminal points supplying irrigation equipment.

The upgraded network configuration supports the integration of modern irrigation technologies, including mobile pivot systems, while reducing friction losses and improving overall system efficiency. Additional hydraulic protection elements were included to enhance operational safety and durability.
