Identification, Analysis and Suggestions for Accident Blackspots

In the study the four black spots along the state highway-39 was recognized. The current conditions and causes for the accidents were analyzed based on the data procured from first information report. Later these spots were physically examined and the suggestions for possible reduction of the fatalities were provided. Accident density and weighted severity index were determined and potential suggestions to reduce the fatalities are described. The measures are suggested to reduce the accidents. Since, safer roads provide safe journey for all the stake holders.

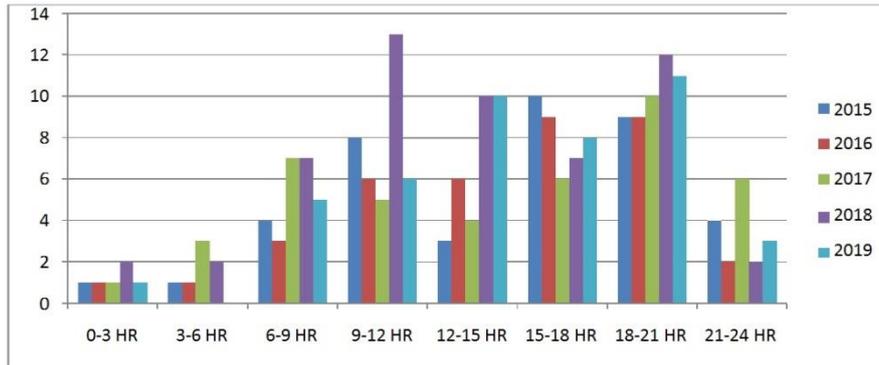
Fig.2. Accident time from year 2015 to 2019

The accidents record for the five years in this route was plotted in figure 2 and it was noted that the accidents were more between 3:00 pm to 9:00 pm.

In all these black spots from the last 5 year accident data we can observe that highest number of accident were registered in the year 2018, total number of accidents were 56 and fatal were 9, grievous were 20 and minor were 27. As per the study, most of the fatal accidents were by the motorcycles at these black spots.

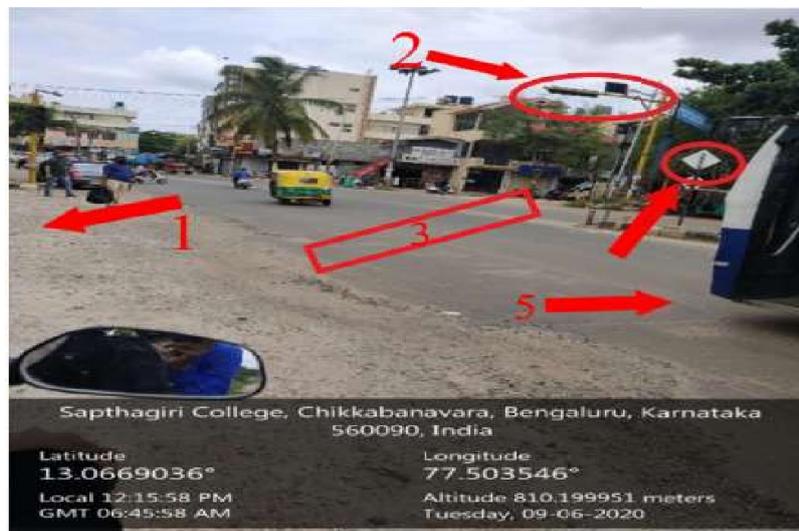
Fig.3. Location of Sapthagiri engineering college junction

From the figure 3, it can be noted that the foot path provided in not appropriate (1) highlighted in red). Then the traffic signal (2) is not function, zebra crossing (3) for pedestrians is missing. Then sign boards (4), speed breaker (5) and other markings are missing.

Table 3. Existing road conditions at Chikkabanavara, India

| Sl. No. | Categories | Sub-categories | Specific |
| 1 | Police records (FIR) | Accidents | 34 fatal injuries |
| 2 | Road Conditions (IRC:SP027) | Pavement failure Foot paths Speed breaker | Completely Uneven None |
| 3 | Type of Collision | Head on Back to back Side sweep | 13 20 01 |
| 4 | Sign Board | Sign boards and indication | None |

| 5 | Visibility | Day and Night | Good |
| 6 | Bush Clearance | Shreds and other | None |
| 7 | Street Light | Halogen or LED | Exists |

- a) Marking and delineators need to be provided.
- b) Mandatory signal and sign board for speed limits
- c) Foot path for pedestrians to be provided on both sides
- d) The unevenness need to be addressed
- e) Standard median to be built upon

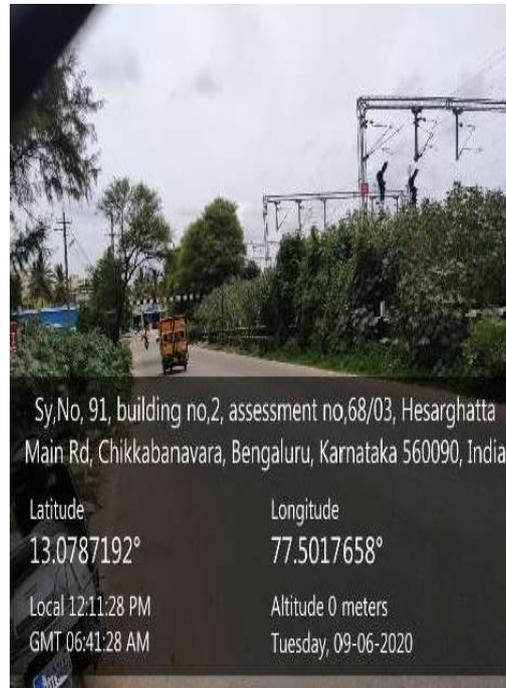
Fig.4. Location of Chikkabanavara

Table 4. Existing road conditions at Chikkabanavara

| Sl. No. | Categories | Sub-categories | Specific |
|---|---|---|---|
| 1 | Police records (FIR) | Accidents | 29 fatal injuries |
| 2 | Road Conditions (IRC:SP027) | Pavement failure Foot paths Speed breaker | Partially Uneven Non-scientific |
| 3 | Type of Collision | Head on Back to back Side sweep | 12 15 02 |
| 4 | Sign Board | Sign boards and indication | None |
| 5 | Visibility | Day and Night | Fair/Bad |
| 6 | Bush Clearance | Shreds and other | Exists |
| 7 | Street Light | Halogen or LED | Does not exists |

From figure 4, the issues like sign board, road conditions and others can be observed. So, the suggestions to reduce the accidents are given below:

- a) Marking and delineators need to be provided.
- b) Mandatory signal and sign board for speed limits.
- c) Foot path for pedestrians to be provided.

- d) All the pot holes need to be filled and natural drains to be provided.
- e) Street lights to be provided.
- f) Standard median to be built upon.

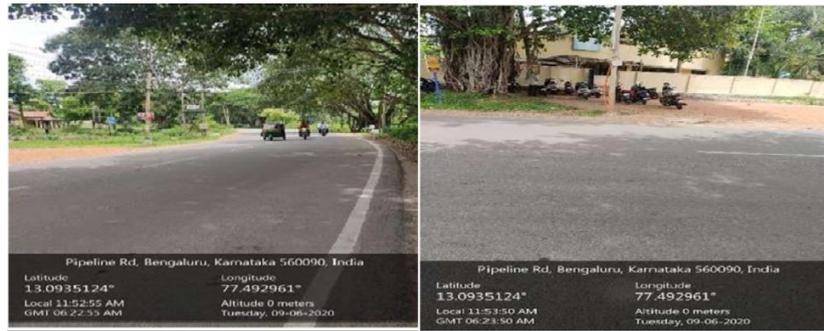
Fig.5. Location of Soladevanahalli near bescom office

Table 5. Existing road conditions at Soladevanahalli near bescom office

| Sl. No. | Categories | Sub-categories | Specific |
|---|---|---|---|
| 1 | Police records (FIR) | Accidents | 27 fatal injuries |
| 2 | Road Conditions (IRC:SP027) | Pavement failure Foot paths Speed breaker | less None Non-scientific |
| 3 | Type of Collision | Head on Back to back Side sweep | 12 14 01 |
| 4 | Sign Board | Sign boards and indication | None |
| 5 | Visibility | Day and Night | Good/Fair |
| 6 | Bush Clearance | Shreds and other | Exists |
| 7 | Street Light | Halogen or LED | Does not exists |

The figure 5 and table 5 also represents the similar problems faced as the others can be observed, so the suggestions to reduce these are given below:

- a) Marking and delineators need to be provided.
- b) Mandatory sign boards of speed limit need to be provided
- c) Foot path for pedestrians to be provided.
- d) Mild pot holes need to be filled
- e) Street lights to be provided.
- f) Standard median to be built upon.

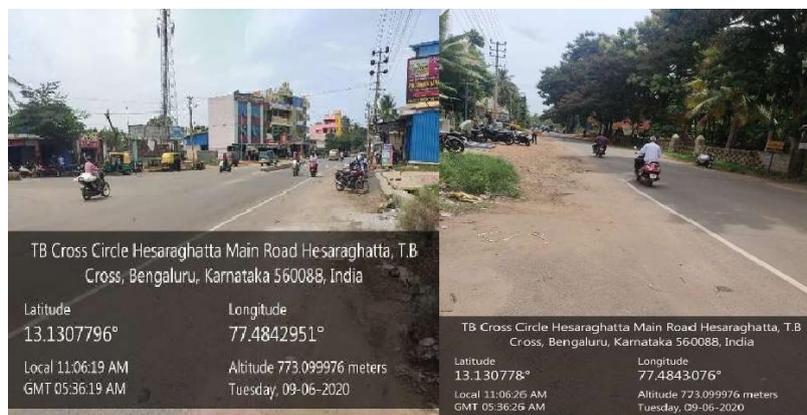
Fig.6. Location of TB cross near hesaraghatta

Table 6. Existing road conditions at TB cross near hesaraghatta

| Sl. No. | Categories | Sub-categories | Specific |
|---|---|---|--|
| 1 | Police records (FIR) | Accidents | 36 fatal injuries |
| 2 | Road Conditions (IRC:SP027) | Pavement failure Foot paths Speed breaker | Existing pot holes None Non-scientific |

| 3 | Type of Collision | Head on | 15 |
| | | Back to back | 18 |
| | | Side sweep | 03 |
| 4 | Sign Board | Sign boards and indication | None |
| 5 | Visibility | Day and Night | Good |
| 6 | Bush Clearance | Shreds and other | Exists |
| 7 | Street Light | Halogen or LED | Does not exists |

- a) Marking and delineators need to be provided.
- b) Mandatory signal and sign board need to be placed.
- c) Foot path for pedestrians to be provided.
- d) All the pot holes need to be filled.
- e) Street lights to be provided.
- f) Standard median to be built upon.
